TEST REPORT

Continuous Immersion Test - IPX8
Dust Test - IP6X

240400068TPE-001

Zoom Bullet with D/N / Z412

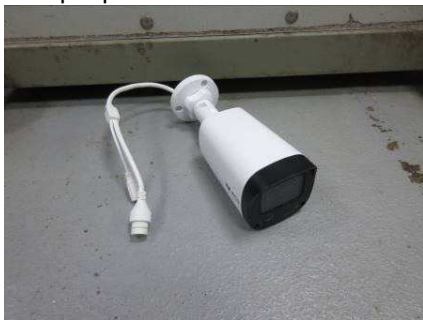
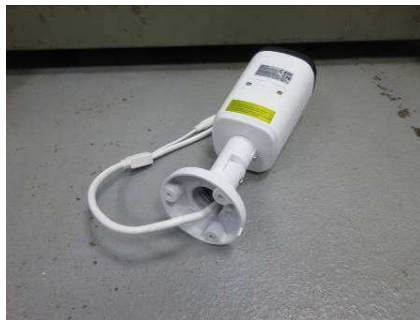
-Sample photo before the test:

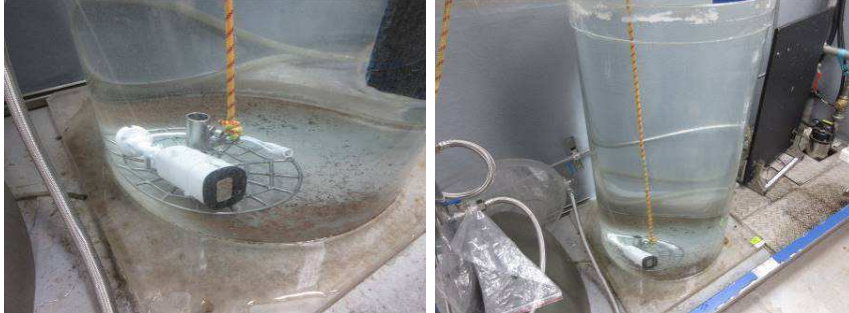
-Setup photo:

Immersion depth : 1100 mm (between the surface of the water and sample's bottom)
The duration of the test : 30 minutes

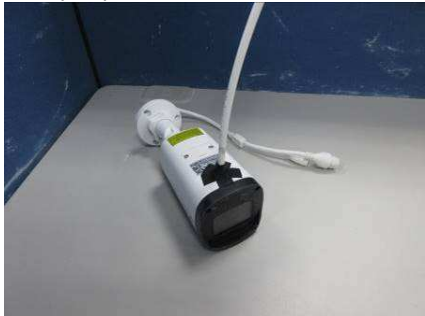
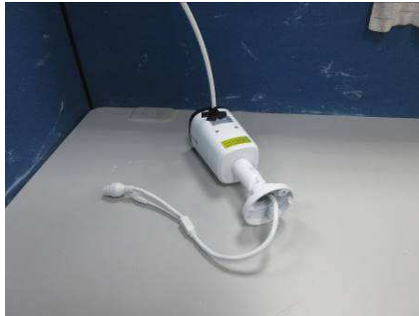
-Sample photo before the test:

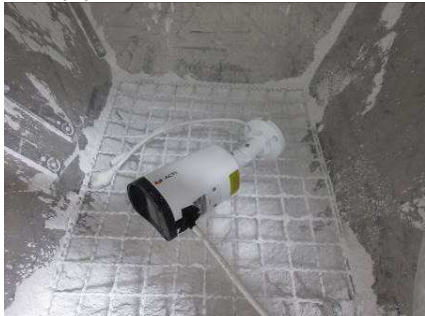
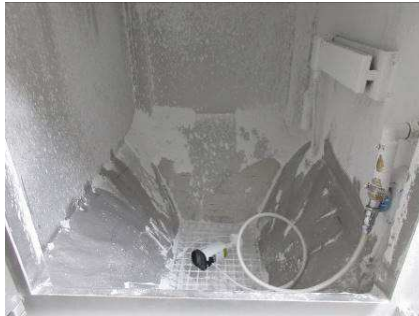
-Setup photo:

-Talcum powder size: < 0.075 mm

-The amount of talcum powder: 2 kg per cubic meter

-Under pressure: 20 mbar

-Test duration: 8 hours

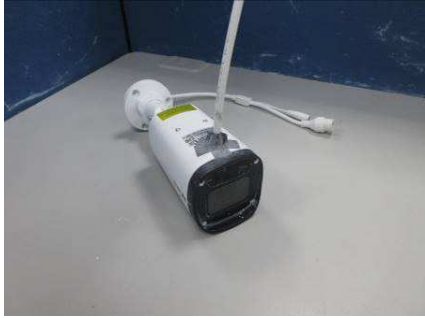
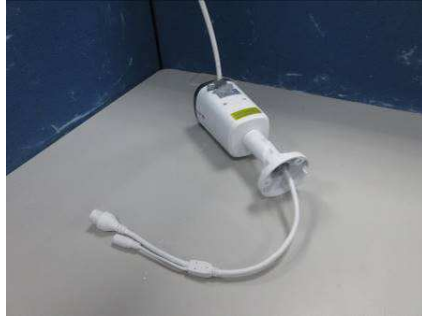
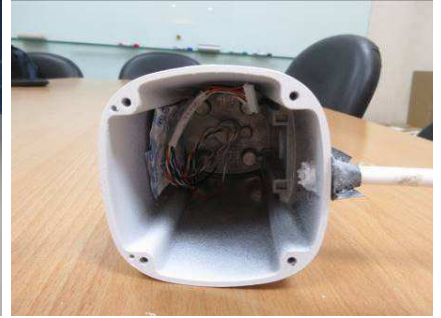
- No visible damage was found on sample appearance after the test.
- Checking for the inside of tested sample after testing is conducted by the applicant per applicant's request.
- No dust penetrated into tested sample.
- Sample photo after the test:
